DEPARTMENT OF TRANSPORTATION**DIVISION OF ENGINEERING SERVICES**

Contract #: 04-0120F4Cty: SF/ALA Rte: 80 PM: 13.2/13.9File #: 1.28**WELDING INSPECTION REPORT****Resident Engineer:**Pursell, Gary**Address:** 333 Burma Road**City:** Oakland, CA 94607**Report No:** WIR-015152**Date Inspected:** 22-Jun-2010**Project Name:** SAS Superstructure**OSM Arrival Time:** 1000**Prime Contractor:** American Bridge/Fluor Enterprises, a JV**OSM Departure Time:** 1830**Contractor:** American Bridge/Fluor Enterprises, a JV**Location:** Job Site

WELDING INSPECTION REPORT

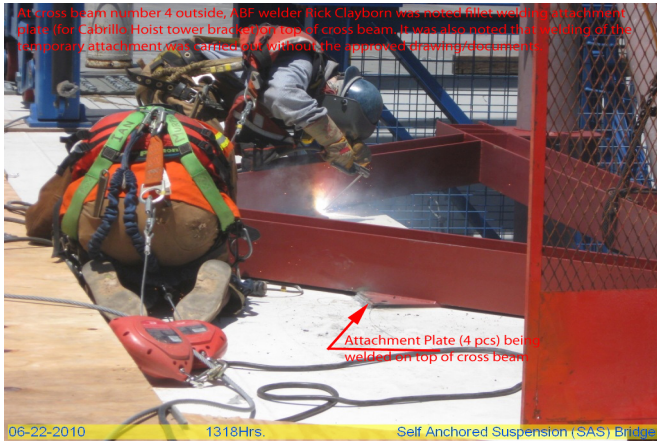
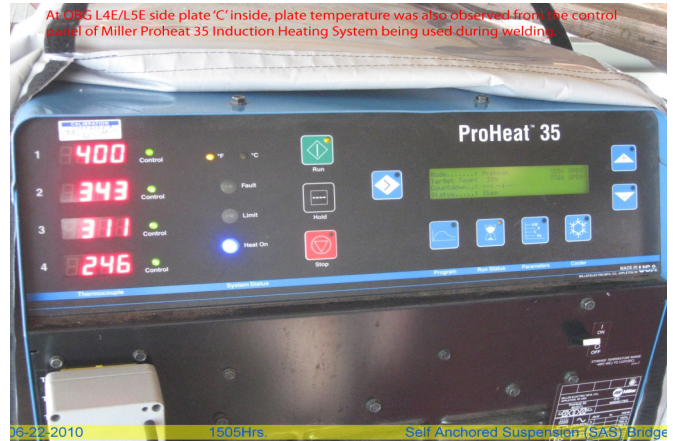
At OBG L4E/L5E side plate 'C' (1000mm to 4770mm) inside, QA randomly observed ABF/JV qualified welder Sungtao, Huang ID # 3794 continue perform CJP groove (splice) welding fill pass. The welder was observed perform automatic welding in the 3G (vertical) position utilizing a dual shield Flux Cored Arc Welding (FCAW-G) with E71T-1M, 1/16" diameter wire electrode and implementing Caltrans approved Welding Procedure Specification (WPS) ABF-WPS-D15-3042A-1. The joint being welded has a single V-groove butt joint with backing bar. The splice joint was preheated and maintained to greater than 200 degree Fahrenheit using Miller Proheat 35 Induction Heating System located at the opposite side of the plate prior/during welding. During welding, ABF Quality Control (QC) Bernie Docena was noted monitoring the welding parameters of the welder.

At OBG L4E/L5E bottom plate 'D' outside, ABF welder Mitch Sittinger was observed perform alternately back gouging and grinding on the splice butt joint backing bar removal of 'D' plate. The welder was using Esab plasma arc gouging machine mounted to a track. During the shift, gouging and grinding of the backing bar and some of the base metal were not completed and should continue tomorrow.

At crossbeam number 4 outside, QA randomly observed ABF welder Rick Clayborn perform fillet welding on two sides of four temporary attachment plates. The plates that were connected to the support bracket that will hold the Cabrillo Elevator tower was welded on top of the cross beam. The welder was using Shielded Metal Arc Welding

(SMAW) with 5/32" diameter E7018H4R electrode. QA noted ABF QC Steven Mc Connell monitoring the welder.
